# MINE SITE REHABILITATION IN SIERRA LEONE — A RAPID APPRAISAL OF SELECTED SITES

## FINAL

**A report on research conducted for**

Environmental Protection Agency - Sierra Leone

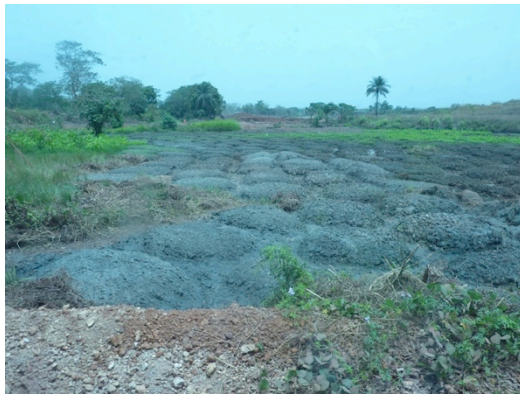
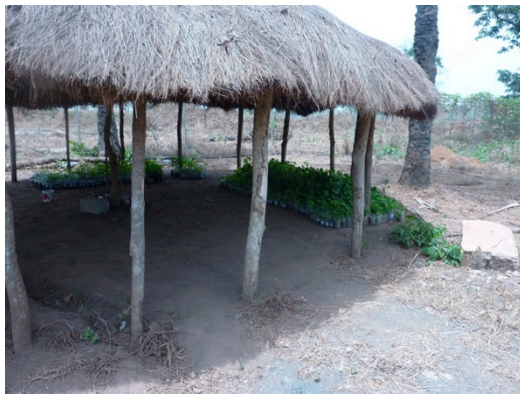
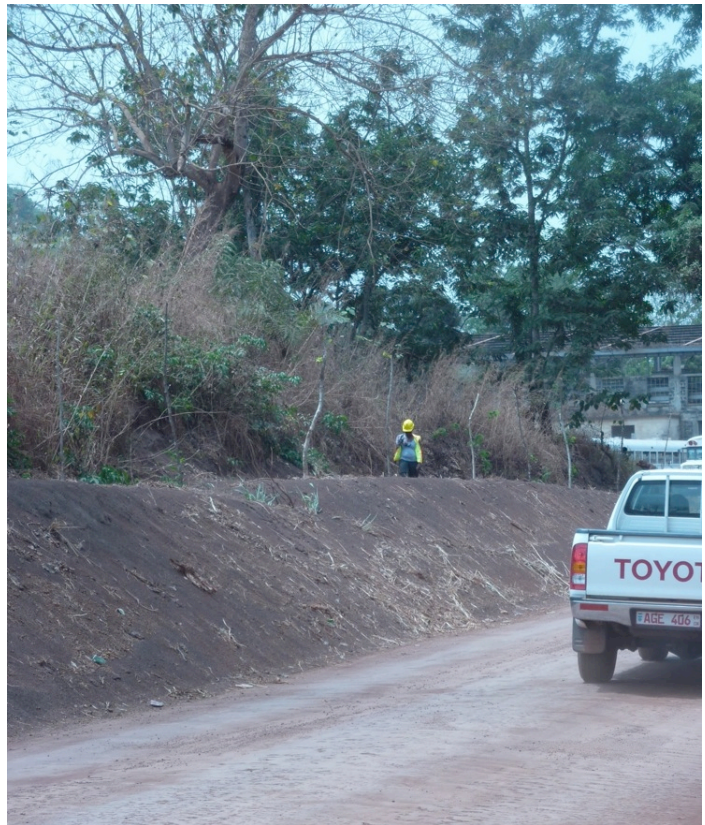
**Figure 1.** Marampa Mine. Top left: Community farming in legacy iron ore tailings. Bottom left: On-site nursery. Right: Revegetation using cuttings to provide shade along a walkway.

- Assess the growth potential of plant species on final tailings material (as opposed to coarser legacy tailings).
- Engage the Community Steering Committee on the proposals set out in the closure plan and consider establishment of a sub-committee on issues of closure planning.
- Ensure community nursery is established and is able to grow a wide selection of species.

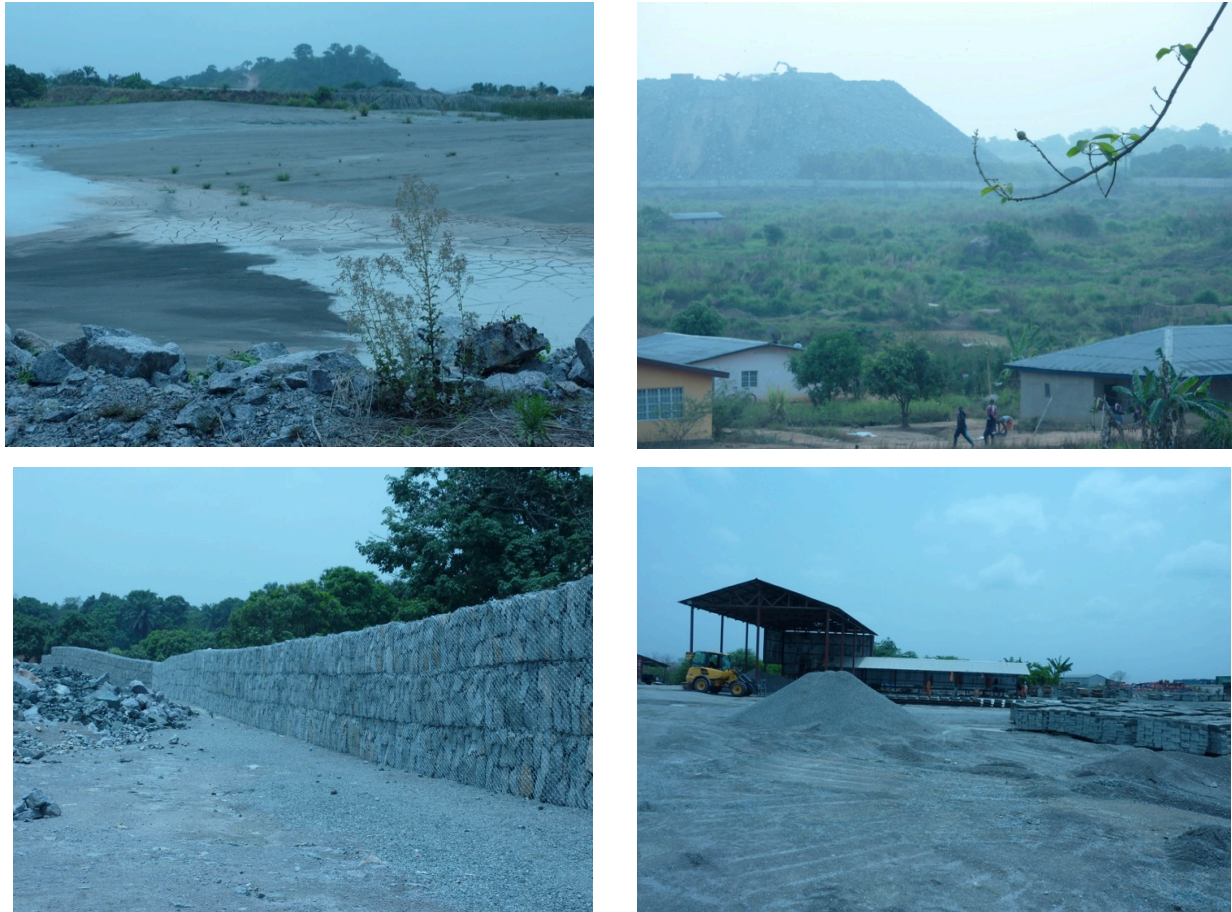
**Figure Two.** Koidu Kimberlite Project. Top left. Disused slimes dam. Top right: Waste rock dump steeply adjoining lease boundary – note the lease boundary rock wall at the foot of the dump. Bottom: Reuse of waste rock in wall construction (left) and brick construction (right).

- A plant nursery should be established on site or within community (as per lease agreement)
- There is an opportunity to rehabilitate the disused slimes dam.

- The batter angle of the waste rock dump immediately adjacent to the lease boundary appears very steep and may be above agreed to requirements – there is a need to undertake detailed assessment as to whether this is the case and what options exist for remedy.

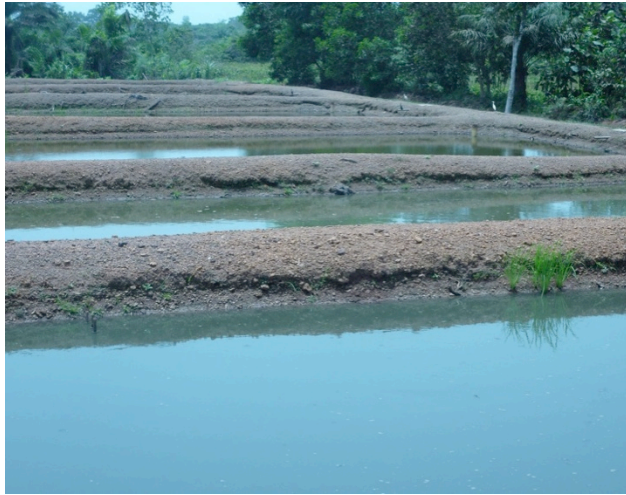
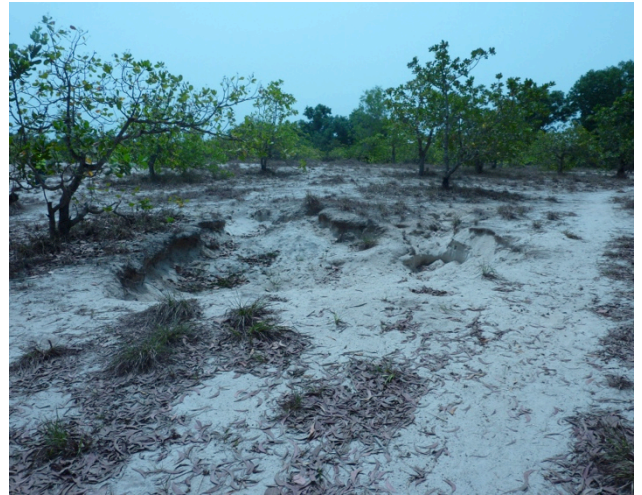
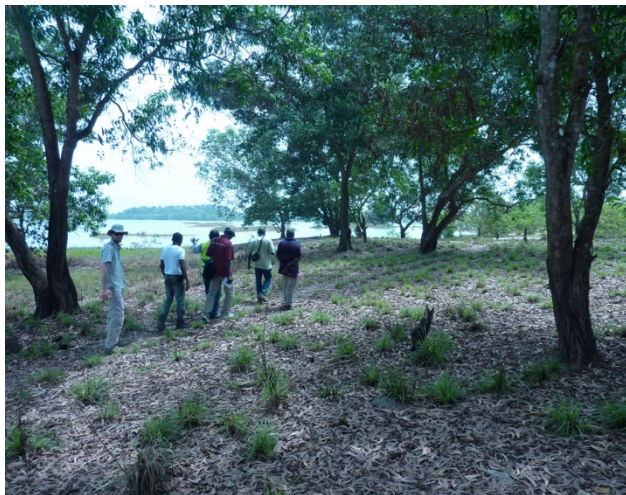
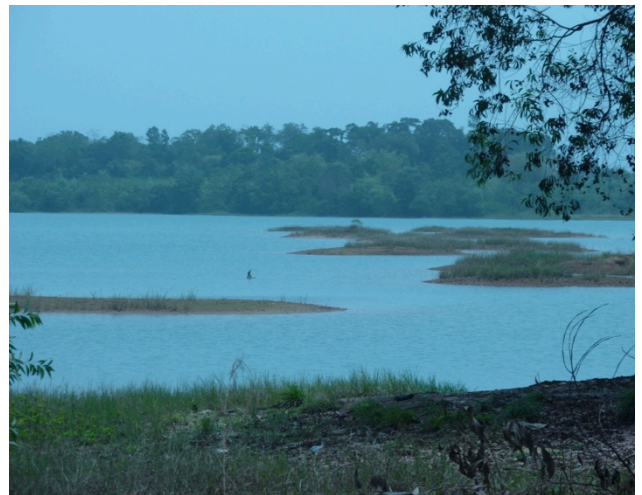
**Figure Three.** Sierra Rutile. Top left: Aquaculture ponds. Top right: Gully erosion on cashew rehabilitated sites. Bottom left: Acacia rehabilitation. Bottom right: Large ponds formed from rutile mining.

- The EPA in consultation with the site should set productivity targets for economic species to provide an agreed to minimum requirement prior to rehabilitation signoff. Adequate growth rates need to be demonstrated by the company as some rehabilitation sites visited during the assessment demonstrated relatively low productivity and an absence of self-generation of species even decades after establishment.

- The EPA should request a review of mining practice at the site and a benchmarking against international best practice in rutile mining. The extensive disturbance created by the pond dredge method should be justified against less intrusive mining methods. This review might also consider the efficacy of separate processing of mineralised topsoil to retain some topsoil for use in rehabilitation.

- Options should be explored to prevent regular fires in selected rehabilitation areas to demonstrate potential for re-colonisation of Acacia's and other species.

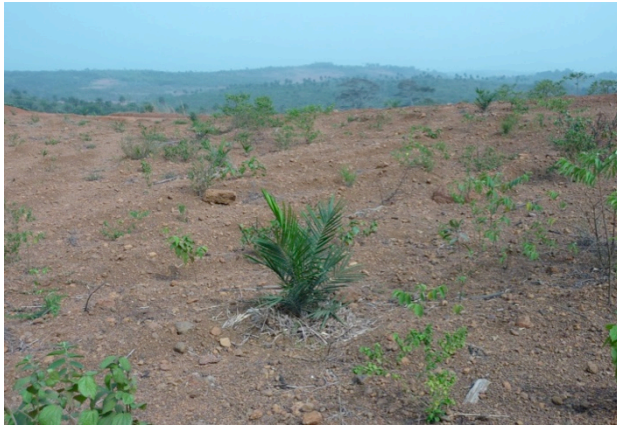
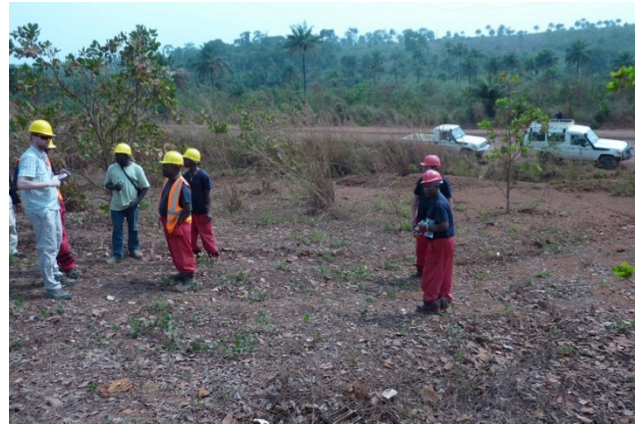
**Figure Four.** Left: Newly planted oil palm on recently mined land demonstrating progressive rehabilitation. Right: Three year old cashew rehabilitation showing solid growth rates.

- Given the decision to use economic species in rehabilitation there is a need to train local community members in oil palm and cashew silviculture and maintenance.

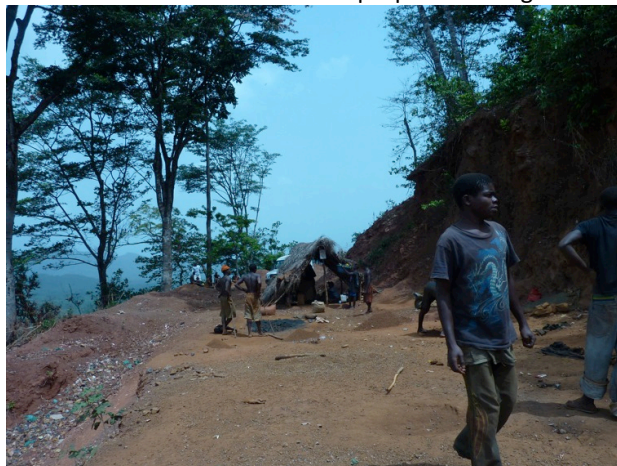
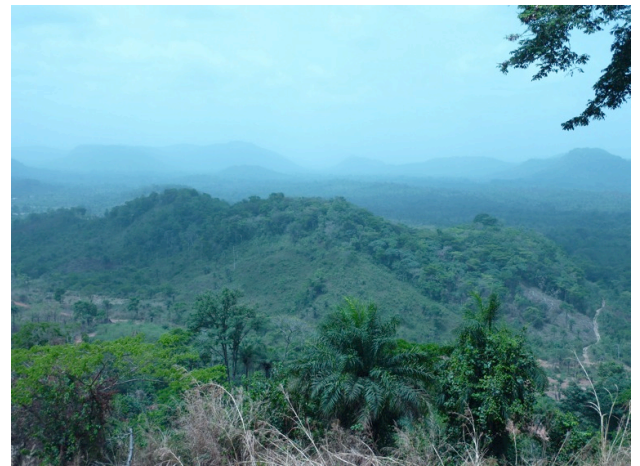
**Figure Five.** Baomahun Gold Project. Left: Artisanal gold miners on an un-rehabilitated disused drill pad. Right: View east from the site towards proposed tailings dam location.

- Rehabilitation of disturbed land from exploration drilling (drill pads) could be attempted in areas where further disturbance is unlikely as a means to demonstrate and improve knowledge in rehabilitation techniques. A range of locally collected species (planted just prior to the wet season) could be tested and monitored to determine which species persist.
- Future drill pads could be ripped and seeded immediately after drill core extraction, as is practice at many exploration sites.
- The site could begin establishment of a (community) nursery and grow a wide selection of native species.

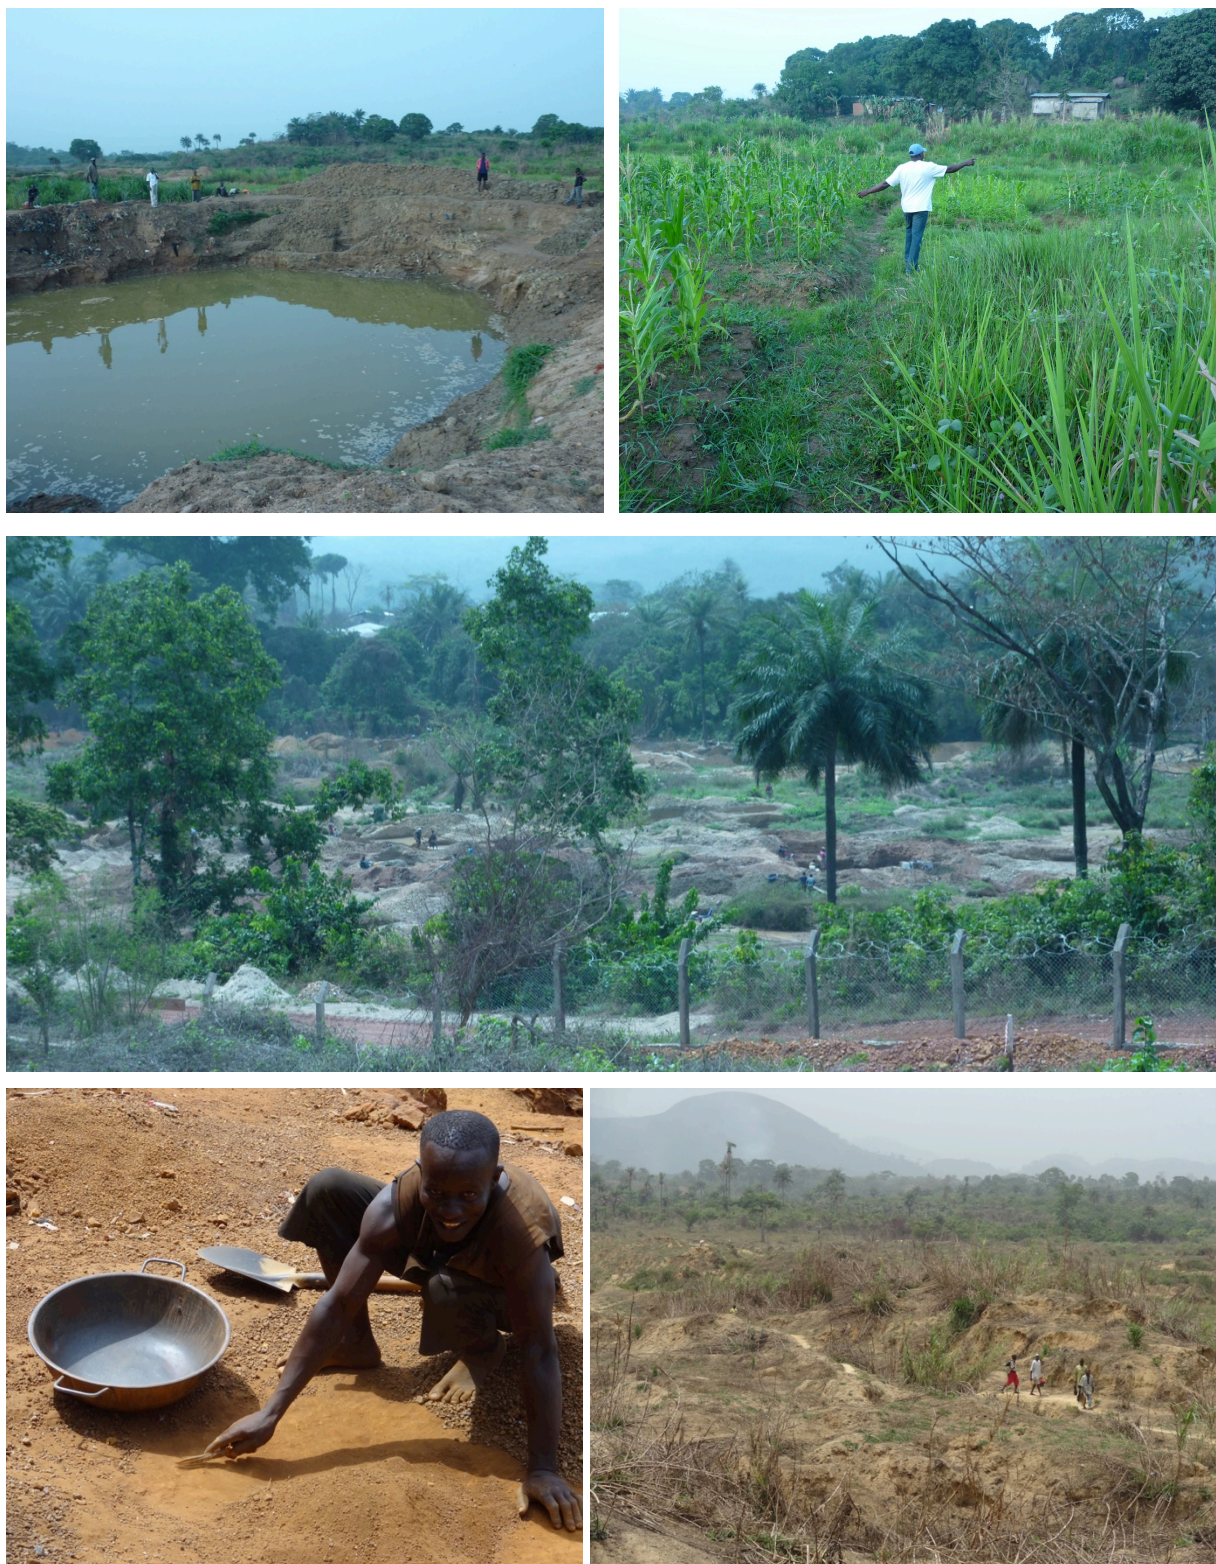
A number of programs have demonstrated that reclamation of artisanal diamond mining sites to productive agriculture is possible using limited financial resources and minimal technical assistance. A project undertaken by the Foundation for Environmental Security and Sustainability (FESS) with funding provided by Tiffany & Co. Foundation and the United States Agency for International Development reclaimed a number of sites using a community-led approach. At Congo Bridge in Kono ~45 acres of land was reclaimed to productive agriculture. The 6-month project employed around 300 people. The main activity consisted of filling in mining pits by shovel. Participants were paid a

The rehabilitation did not require major modification of the soil substrates. The substrates did not appear to exhibit AMD or other difficulties. The success of the program has, however, been undermined by significant social and institutional challenges that did not ensure reclaimed sites were not re-mined.

**Figure Six.** Artisanal mining in Sierra Leone. Top left: Artisanal diamond miners re-mine previously reclaimed land in Kono. Top right: Land reclaimed by FESS to agricultural production in Kono. Middle: Alluvial gold mining, Baomahun. Bottom right: Artisanal gold mining of primary ore, Baomahun. Bottom right: Disturbed land from artisanal diamond mining, Tongo Fields.

Administrative fees are collected by the government from artisanal miners for the purposes of rehabilitation. As noted by many others this creates a disincentive for miners to reclaim areas after mining and a responsibility on government departments to undertake programs. There is an opportunity for the fees collected by government to be used to undertake demonstration projects. Such projects should involve the end users of the reclaimed land in the decision-making and practical activities to generate ownership of the outcomes of the program.

Alternatively, consideration should be given to the replacement of the fee with an environmental bond that is provided back to artisanal miners once post-mining pits have been refilled and re-contoured.
